Davis-Besse Reactor Vessel Head Damage NRC UPDATE

August 2003

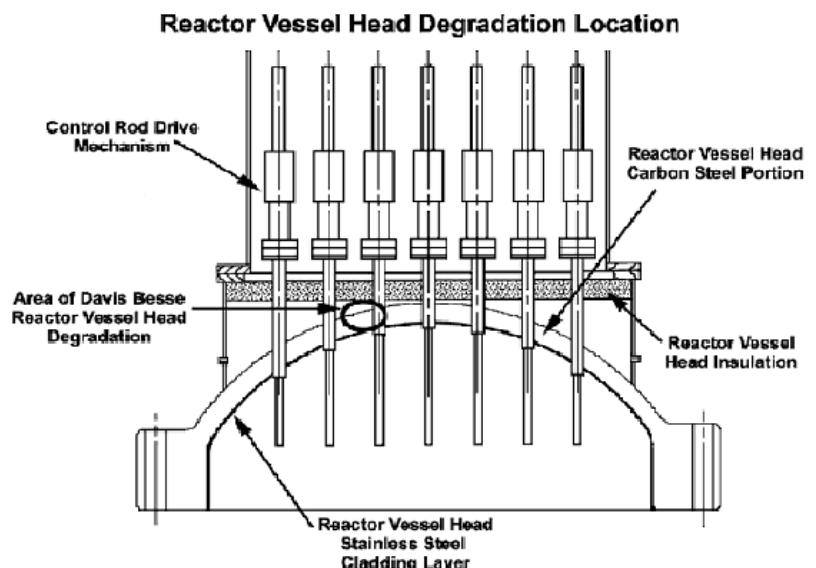
Corrosion, caused by the boric acid, damaged the vessel head next to Nozzle No. 3, creating an irregular cavity about 4 inches by 5 inches and approximately 6 inches deep. The cavity penetrated the carbon steel portion of the vessel head, leaving only the stainless steel lining. The liner thickness varies somewhat with a minimum design thickness of 1/8 inch. Subsequent examination by Framatome, FirstEnergy's contractor, found evidence of a series of cracks in the liner, none of which was entirely through the liner wall.
